**Mascoat**  
P R O D U C T S

**Why Paint  
And then  
Insulate?**

***The Industry Leaders in Thermal Insulation Coatings***

**These are just a few of the hundreds of applications using our insulating coatings. Each application was performed to help insulate and protect substrates in a coating application.**

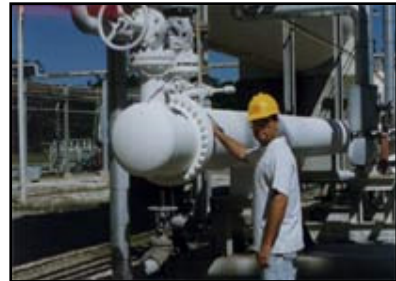
**Substrate: HEAT EXCHANGER**

**Problem:** Corrosion Under Insulation, Personnel Protection  
**Reason for application:** The coating was used for personnel protection. The coating was sprayed onto a working vessel without shutdown and requires only washing for maintenance. The coating has been on the vessel for over six years in an industrial setting with no failures.

**Starting Temp:** 200°F (93 °C)  
 $\Delta T$ : 100°-108 (57-60 °C)

**Post App Temp:** 92°-100°F (33-37 °C)  
**Ambient:** 64°F (17 °C)

**DFT:** 40-60 mils (1-1.5 mm)

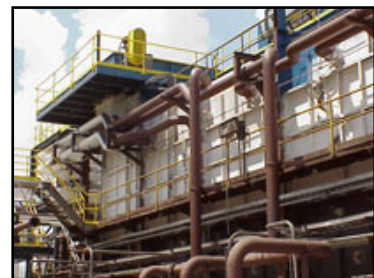
**Substrate: DIFFUSER**

**Problem:** Heat Retention in cold weather, protection for subst.  
**Reason for application:** This diffuser runs a steady temperature of 88°C. It was decided that the substrate should be insulated for heat retention in cold weather and also for personnel protection.

**Starting temp:** 190°F (87 °C)  
 $\Delta T$ : 80°F (64 °C)

**Post App Temp:** 110°F (43 °C)  
**Ambient:** 80°F (26 °C)

**DFT:** 60 mils (1.5 mm)

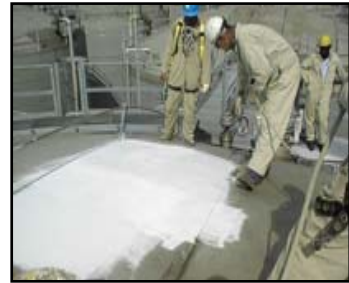
**Substrate: TANK STORAGE FACILITY**

**Problem:** Tanks were imploding during cleaning

**Reason for application:** Over 40 tanks like this one were insulated on the tops to deter implosion of the tanks. At this facility chemicals are stored inside these tanks for short time. After storage, each tank has to be steam cleaned to be readied for the next chemical. During the summertime, rain showers were super cooling the metal causing pressure differentials and thus implosion would occur. To date, no implosions have occurred since the tanks were coated.

**Starting temp:** 300°F (148 °C) steam

**DFT:** 30 mils (0.75 mm)

**Result:** *NO IMPLOSIONS*

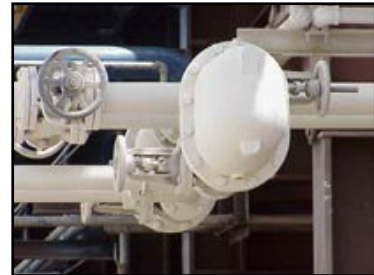
**Substrate: VALVE ASSEMBLY**

**Problem:** Corrosion Under Insulation (CUI)

**Reason for application:** This valve assembly was continuously replaced due to a CUI problem. This conventional insulation was applied to protect personnel from burns, yet it was below a steaming point so moisture would be entrapped. After the coating was applied the valve was protected. The valve can also be serviced with minor touchups.

**Starting temp:** 200°F (93 °C)

$\Delta T$ : 75°F (41 °C)

**Post App Temp:** 100°F (52 °C)

**Ambient:** 71°F (21 °C)

**DFT:** 30 mils (0.75 mm)

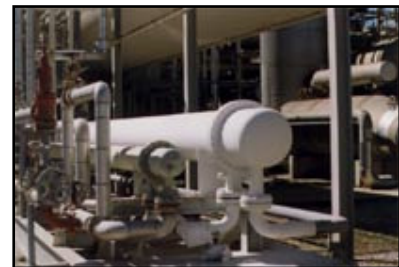
**Substrate: PROCESS EXCHANGER**

**Problem:** Heat Retention, Corrosion Under Insulation (CUI), personnel protection

**Reason for application:** This processor was designed to help a chemical process occur over time. This substrate was coated with Delta T Industrial Coating so the process could occur with desired temperature.

**Starting temp:** 300°F (148 °C)

$\Delta T$ : 145°F (84 °C)

**Post App Temp:** 155°F (64 °C)

**Ambient:** 71°F (21 °C)

**DFT:** 60-100 mils (1.5 – 2.5 mm)
